NASA TECHNICAL MEMORANDUM

NASA TM-82454

ENVIRONMENTAL DURABILITY OF ELECTROPLATED BLACK CHROMIUM

By James R. Lowery
Materials and Processes Laboratory

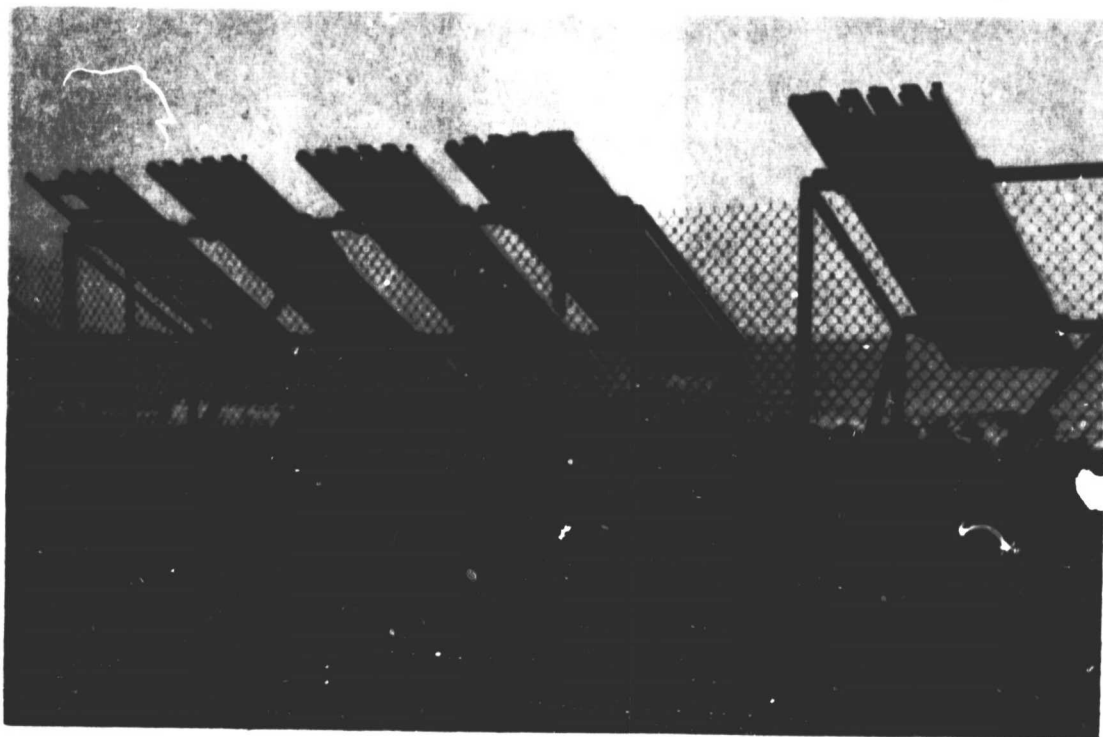
Figure 4. Atmospheric exposure racks located on the beach at KSC.

This test site, located at Kennedy Space Center near Titusville, Florida, represents an environment which causes extremely high corrosivity because of the sea spray. Test specimens were exposed for a total of 13 months at two different locations in this area: (1) approximately 120 ft from the mean high tide line and (2) 1 mi inland. The panels were mounted at a 30-degree angle on racks that were facing the ocean in an easterly direction. A typical rack is shown in Figure 4.
